FIRST RESULTS – CORRELATION BETWEEN IR IMAGES AND ELECTRICAL BEHAVIOR AND ENERGY YIELD OF PV MODULES

*BEC-Engineering GmbH • Mitterfeldring 41 • D-85586 Poing

2 THERMAL EFFECTS OF PV MODULES

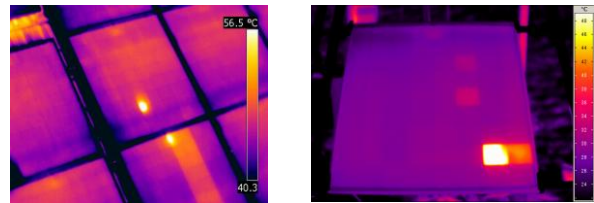
Figure 1: PV module with hot spot (left) / heated cell (right)

The left image in figure 1 shows a PV module under operating conditions with a hot spot. The increase of temperature compared to the rest of the module is about 40 K and the absolute temperature is more than 90°C. This can lead to an irreversible damage of the PV module [2]. The power loss due to a local hot spot achieves in this case up to 10 percent caused by a defect soldering joint, which causes a higher series resistance.

In the right image of figure 1 a hot cell is shown. The temperature difference between the hot cell and the average temperature of the module amounts 13 K. Generally the reason for this effect can be a defect cell and / or mismatch effects [3] or local staining.

Therefore the interpretation of thermal effects shown in figure 1 and 2 can be difficult because there are several different electrical failures, which can cause a thermal phenomenon. Figure 3 and 4 give an overview about thermal effects, in relation to the IR images and some of their possible reasons.

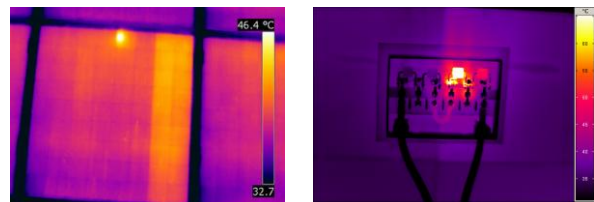
Figure 2: PV module with an open loop cell array (left) and corresponding overheated bypass diode (right).

In Figure 2 an open loop cell array (left) with a corresponding overheated bypass diode is shown.

The temperature difference between the hot cell array and the normal cell arrays is 2 K, and the cell array produces no output power. The reason for that is a soldering joint problem in the heated cell array.

Another possibility for this IR image could be a defect bypass diode (shown in figure 2, right image). In both cases the cell array is slightly warmer than the rest of the PV module, because the absorbed solar power is only converted into heat, and the bypass diode heats up.

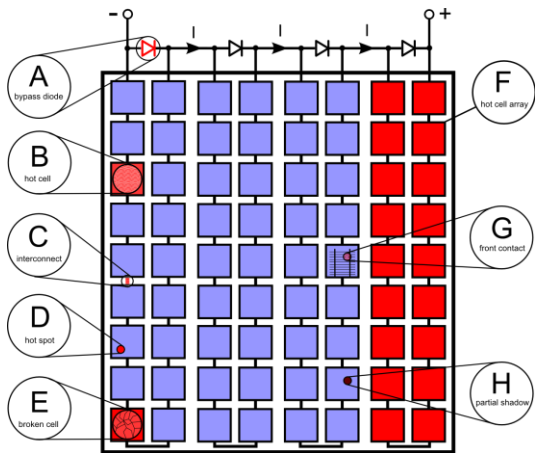
Figure 3: Overview about electrical failures which can cause noticeable thermal effects

In figure 3 these reasons are shown exemplarily on a schematic PV module. The thermal effects of broken cells are not yet verified, also effects without impact to the electrical behavior of the PV module are not considered in figure 4 (for example delaminating). Some effects are interconnected to each other, for example a hot cell array can be caused by an interconnection failure or a bypass diode defect as described above.

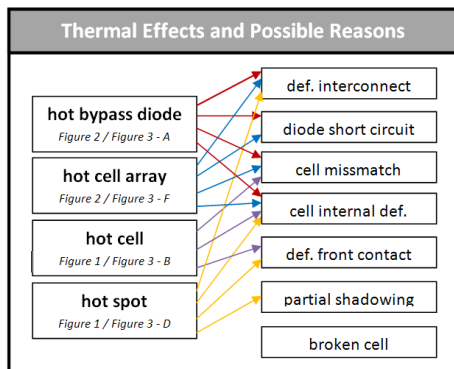
Figure 4: Relation between thermal abnormalities and possible electrical reasons

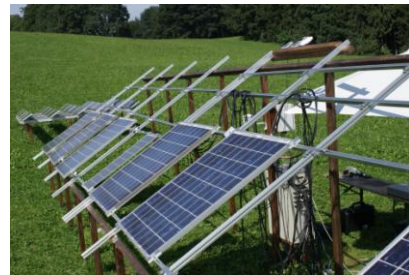
All measurements were realized on an Outdoor Test Stand (figure 5), located in Bavaria, Germany. In the past many measurements of PV plants were made and modules with thermal anomalies were removed for a detailed examination. One representative PV module without thermal or electrical phenomena with average output power was additionally used as reference for every measurement.

- Weather station with mono- and polycrystalline calibrated solar cells, pyranometer, air temperature sensor, wind speed- and direction sensor with a sampling rate of one second
- Free programmable high accuracy Electronic Load samples every 1 minute one complete I-V curve of the complete module, all cell arrays and one reference module
- High resolution IR camera takes every minute one image

Figure 5: Outdoor Test Stand, BEC-Engineering GmbH

An electrical cabinet was used to successively switch a maximum of eight channels to the Electronic Load. In a one minute measurement cycle, the first channels were used to measure the I-V curves of the cell arrays, and the next channels were used for the entire module and a reference module. Between each measurement cycle, the module was held in MPP to simulate standard operating and thermal conditions. Metrological data like global irradiation on a tilted plane and ambient temperature were measured with a one second time resolution. Additionally one IR picture was taken every minute. All measurement values were automatically saved in a log file for a later analysis.

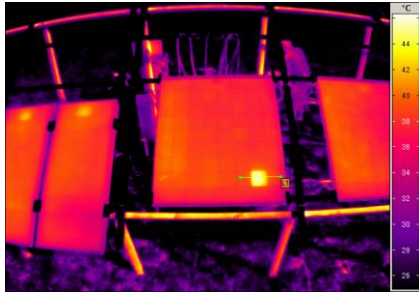
A PV module with one particular heated solar cell was detected in a PV plant using IR imaging (figure 6). This module was analyzed more in detail. It consists of four cell arrays, each with 18 cells in series and one bypass diode per cell array in parallel. This gives in sum 72 cells in series. The I-V curves of all 4 cell arrays, the entire module and one reference module were measured. Figure 7 shows the results for one measurement cycle. All cell array I-V curves, mathematically added, give as expected the measured I-V curve of the complete module.

Figure 6: PV module with one single heated cell

The temperature difference along the considered line L1 has a maximum delta of about 9 K ($G_{\text{mod}} = 622 \text{ W/m}^2$, $T_{\text{amb}} = 24.3 \text{ }^\circ\text{C}$). The measured I-V curves show a significant power loss at the fourth cell array where the heated solar cell is located (figure 6).

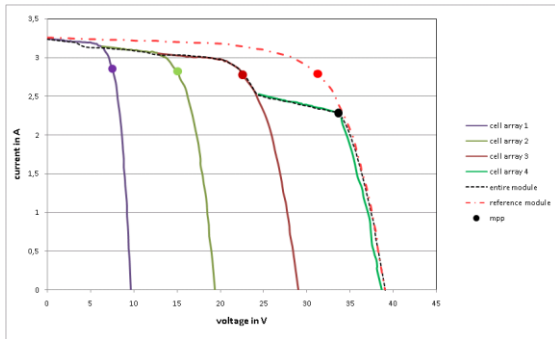
Figure 7: I-V curve of one PV module and its four separate cell arrays.

While the first three cell arrays show only very little deviation among each other, the fourth cell array has a clear decrease of the MPP current. The reference module, which has a common I-V curve, is also drawn in figure 7. Table 1 shows the significant electrical values.

Comparing the four cell arrays among each other, it is obvious that cell array four has a large impact on the MPP current of the entire module, which of course also affects the resulting MPP power. The effect on a complete module string in operation conditions and the resulting power loss will be analyzed in the future. The same module was measured over a longer period on a sunny day with only few clouds, to determine a possible correlation between temperature differences, power loss and irradiation values. The temperature is measured between the heated cell and the average temperature of the module. Figure 8 shows a selected profile of 1.5 hours. The spontaneous steps in the characteristic at a time of 09:14 and 09:56 could not be explained. Neither the irradiation nor the ambient temperature give an indication of an influence on the measured values. However, it appears that the temperature difference is still correlated to the power difference between the concerning cell arrays.

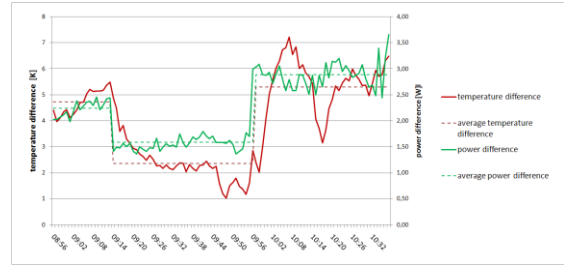
Figure 8: Exemplary temporal course of temperature and power difference comparing normal cell strings to those with thermal anomalies

Figure 9 shows the MPP power differences between the cell array with the heated cell and the average power of the other three cell arrays sorted by irradiation classes. The data points are based on the same series of measurements as in figure 8.

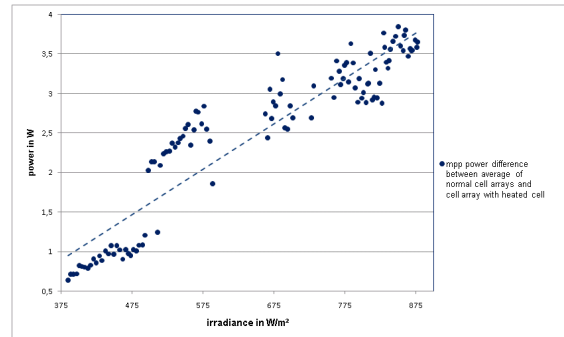
Figure 9: MPP power deviation between normal cell strings to those with thermal anomalies in relation to the irradiance

Obviously there is an approximately linear behavior: the power loss increases with rising irradiation values.

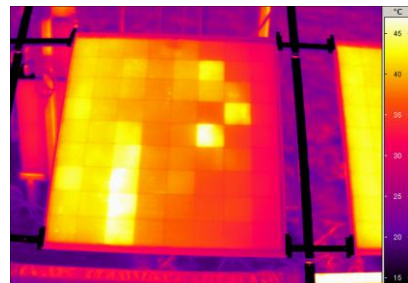
A PV module with multiple heated solar cells has been examined. Like the module before, this module consists of four cell arrays, each with one bypass diode in parallel. Figure 10 shows the considered module in operating conditions ($G_{\text{mod}} = 817 \text{ W/m}^2$ in tilted plane and $T_{\text{amb}} = 19.3 \text{ }^\circ\text{C}$).

Figure 10: PV module with multiple heated cells

There are several heated areas in this module. Each single cell array contains at least one cell that has a higher temperature than the average temperature of the module. The second cell array has at least four hot cells (cell array 2: $T_{\text{max}} = 49.6 \text{ }^\circ\text{C}$, $T_{\text{avg}} = 40.4 \text{ }^\circ\text{C}$).

In cell array one (cell array 1: $T_{\max} = 47.5$ K, $T_{\text{avg}} = 41.4$ °C) the entire cell array is warmer than the total average temperature (entire module: $T_{\text{avg}} = 38.3$ °C). The I-V curves of this module are shown in figure 11.

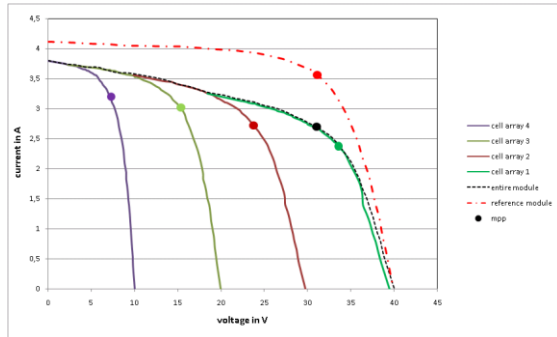
Figure 11: I-V curve of one PV module and its four separate cell arrays

Obviously, the four cell arrays show a clear inconsistency. The power difference between the hottest and the least hot cell array amounts 18.3% (table 2: Δ_1). The relevant electric and thermal values are listed in table 2:

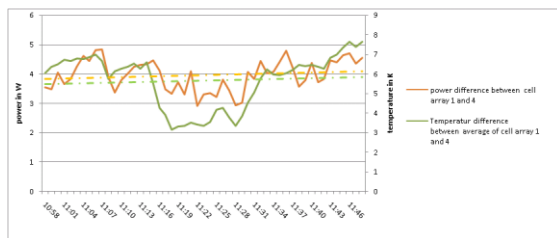
Comparing the average temperature of each cell array with each other, the power output seems to correspond with the average temperature. The correlation between the average temperature of the cell arrays and the comparable power loss will be verified in future measurements. The long term behavior of the temperature and power difference between cell array one and four is shown in figure 12

Figure 12: Exemplary temporal course comparing the average temperature and the power difference between the two cell strings with the largest deviance

Even though the measurement offers inconsistencies regarding the irradiance and resulting power differences, a correlation between temperature and power difference can be seen.

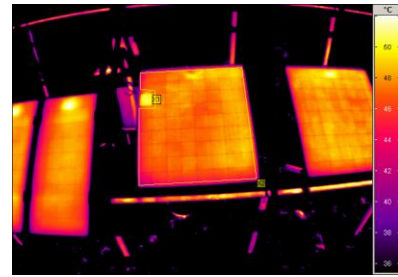
Another module with one single heated cell (figure 13) has been measured. Like the modules before, it consists of four cell arrays, and one bypass diode parallel.

Figure 13: PV module with one single heated cell

The temperature delta between the heated cell in cell array 1 and the average of the module area amounts only 2.0 K, but the measured I-V curve (figure 14) shows a noticeable power loss compared to the reference module.

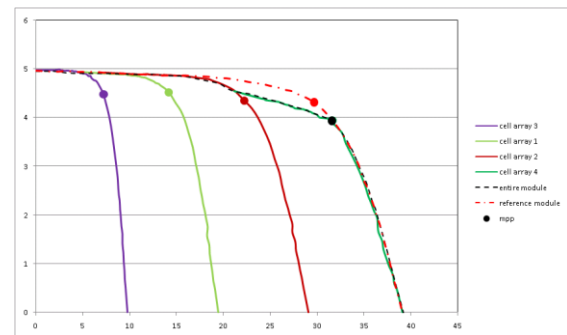
Figure 14: I-V curve of the measured PV module and its four separate cell arrays.

Even a temperature delta of few degrees can show a clear impact to the electrical behavior of the PV module.
